JESUSITA TRAIL

MANAGEMENT/REHABILITATION PLAN

3/15/07

Prepared by Ray Ford
LPFA Trail crew

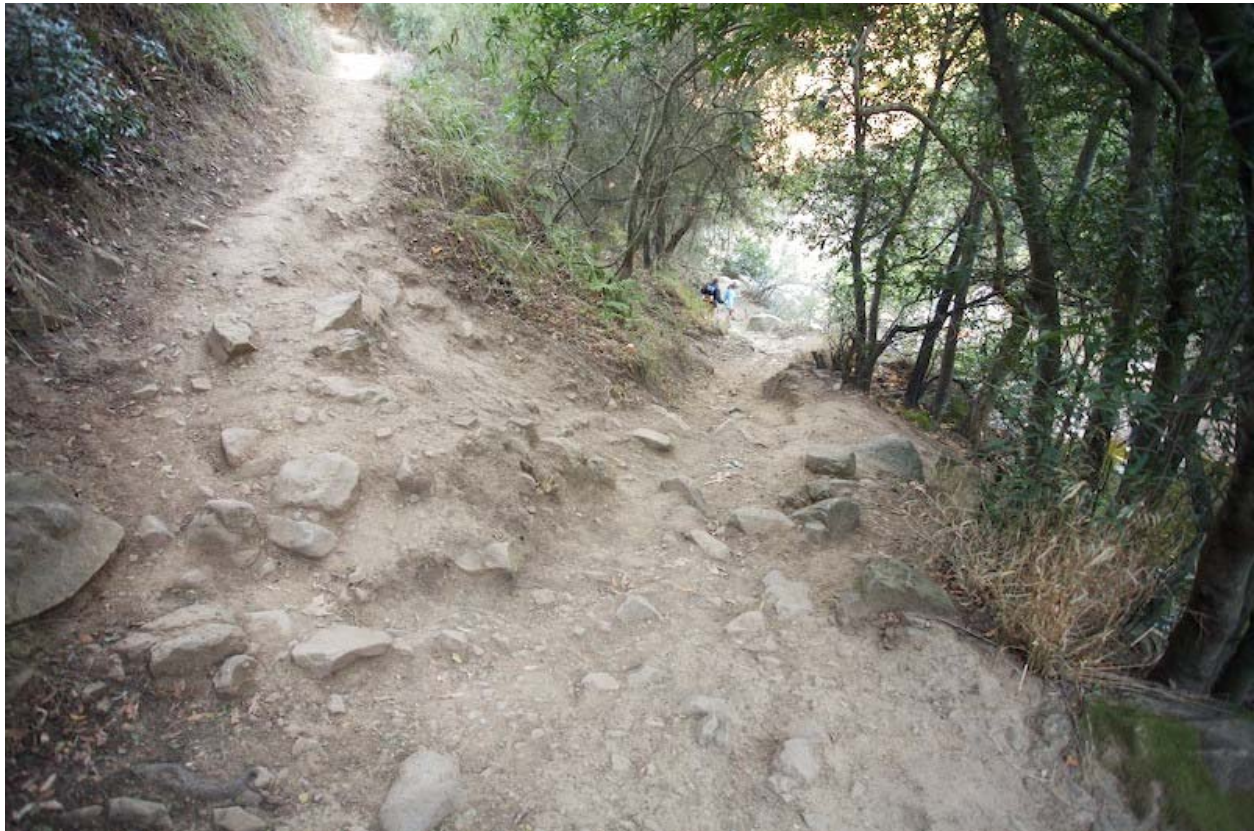
Typical switchback in need of repair. 24% grade in and 29% grade down to creek.

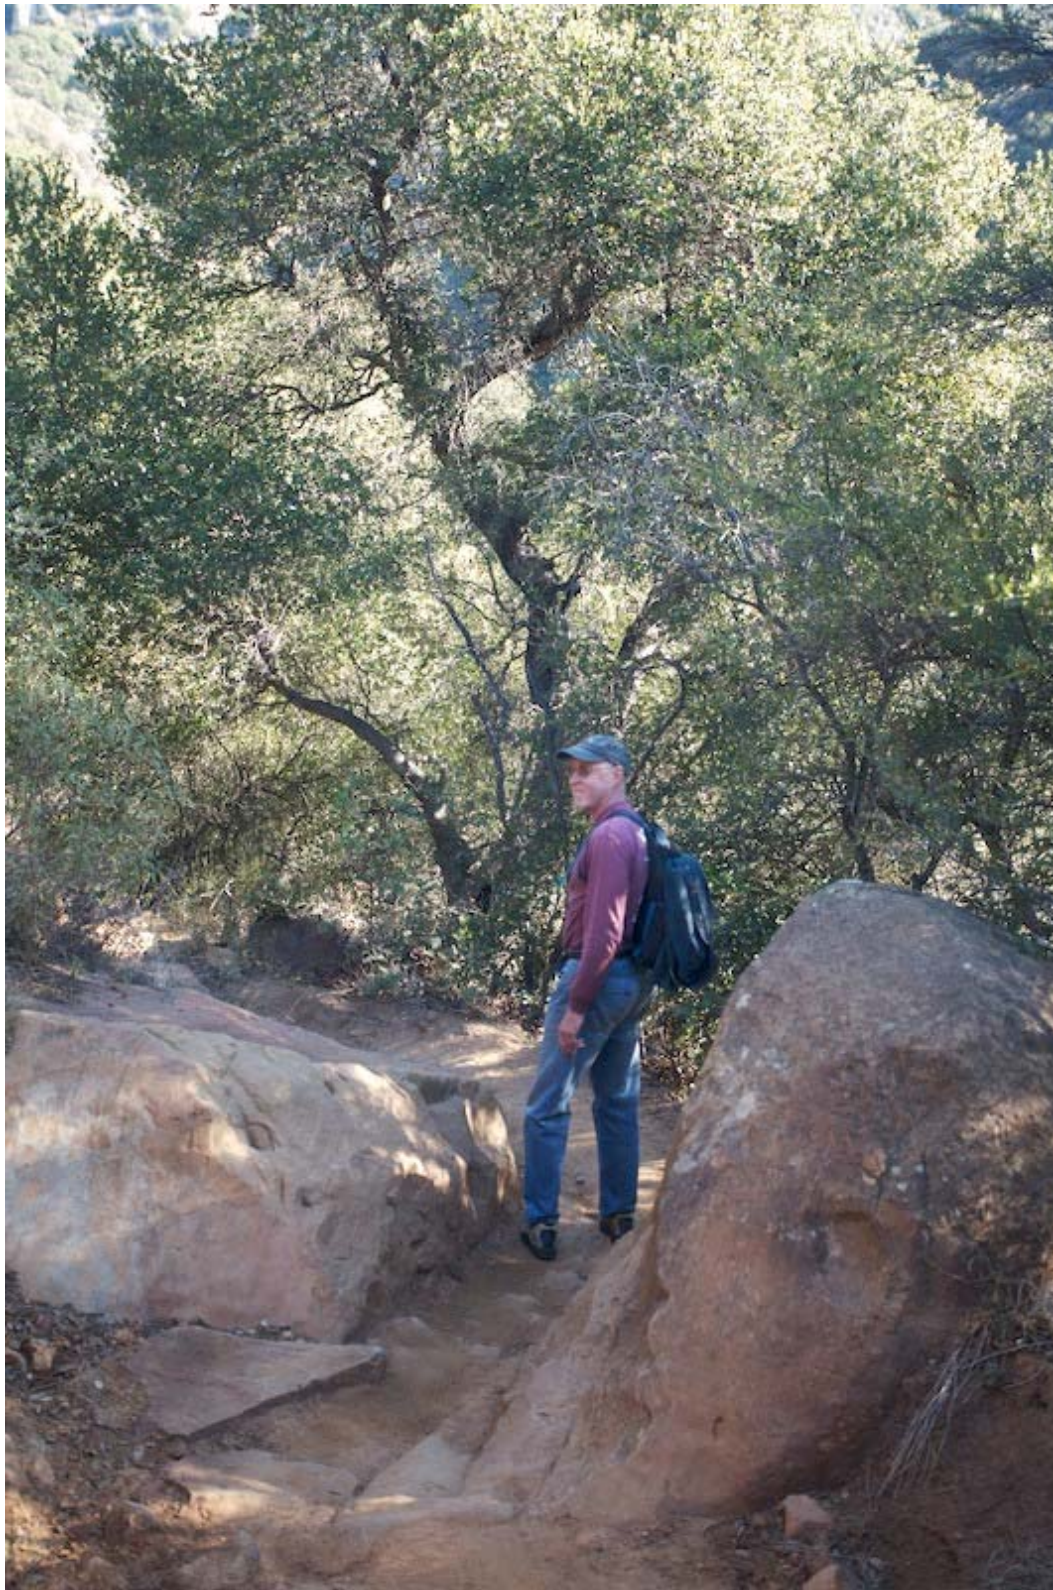
Shows narrow tread running between two boulders. Lower of the two rocs is often used as a jump by mountain bikers.

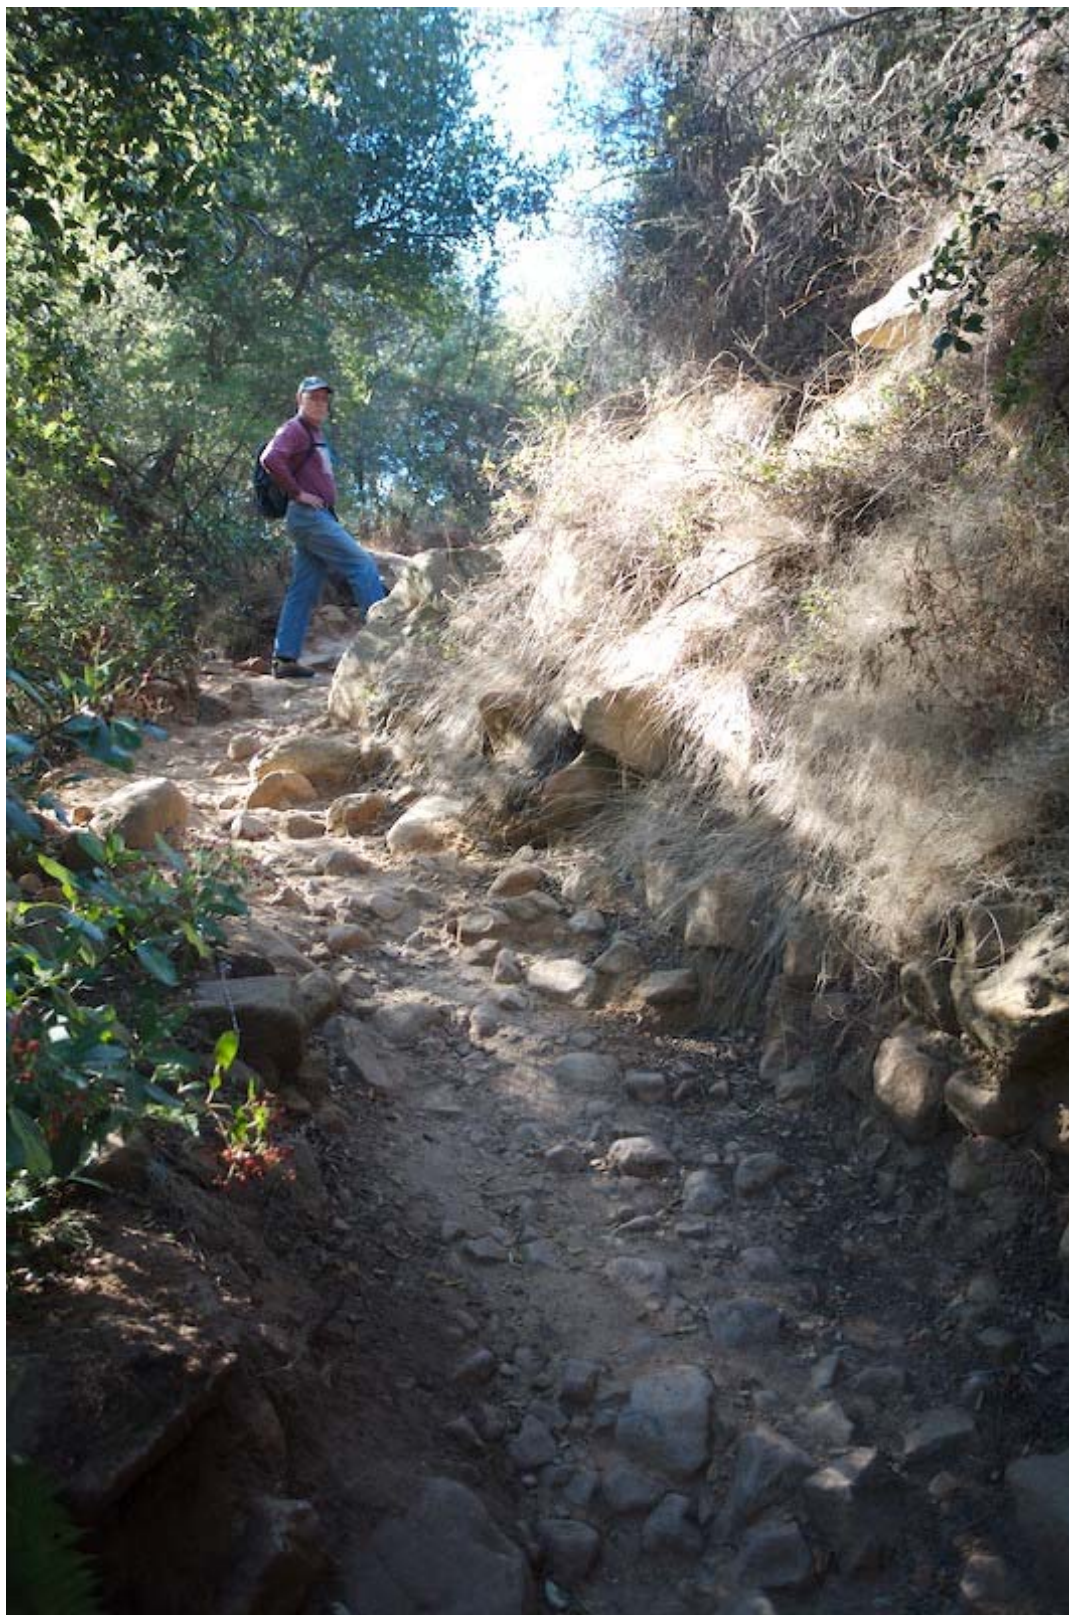
Typical of the tread on the trail leading from Mission Canyon up to Inspiration Point. Rutted, extremely rocky and no way for the water to get off the trail.

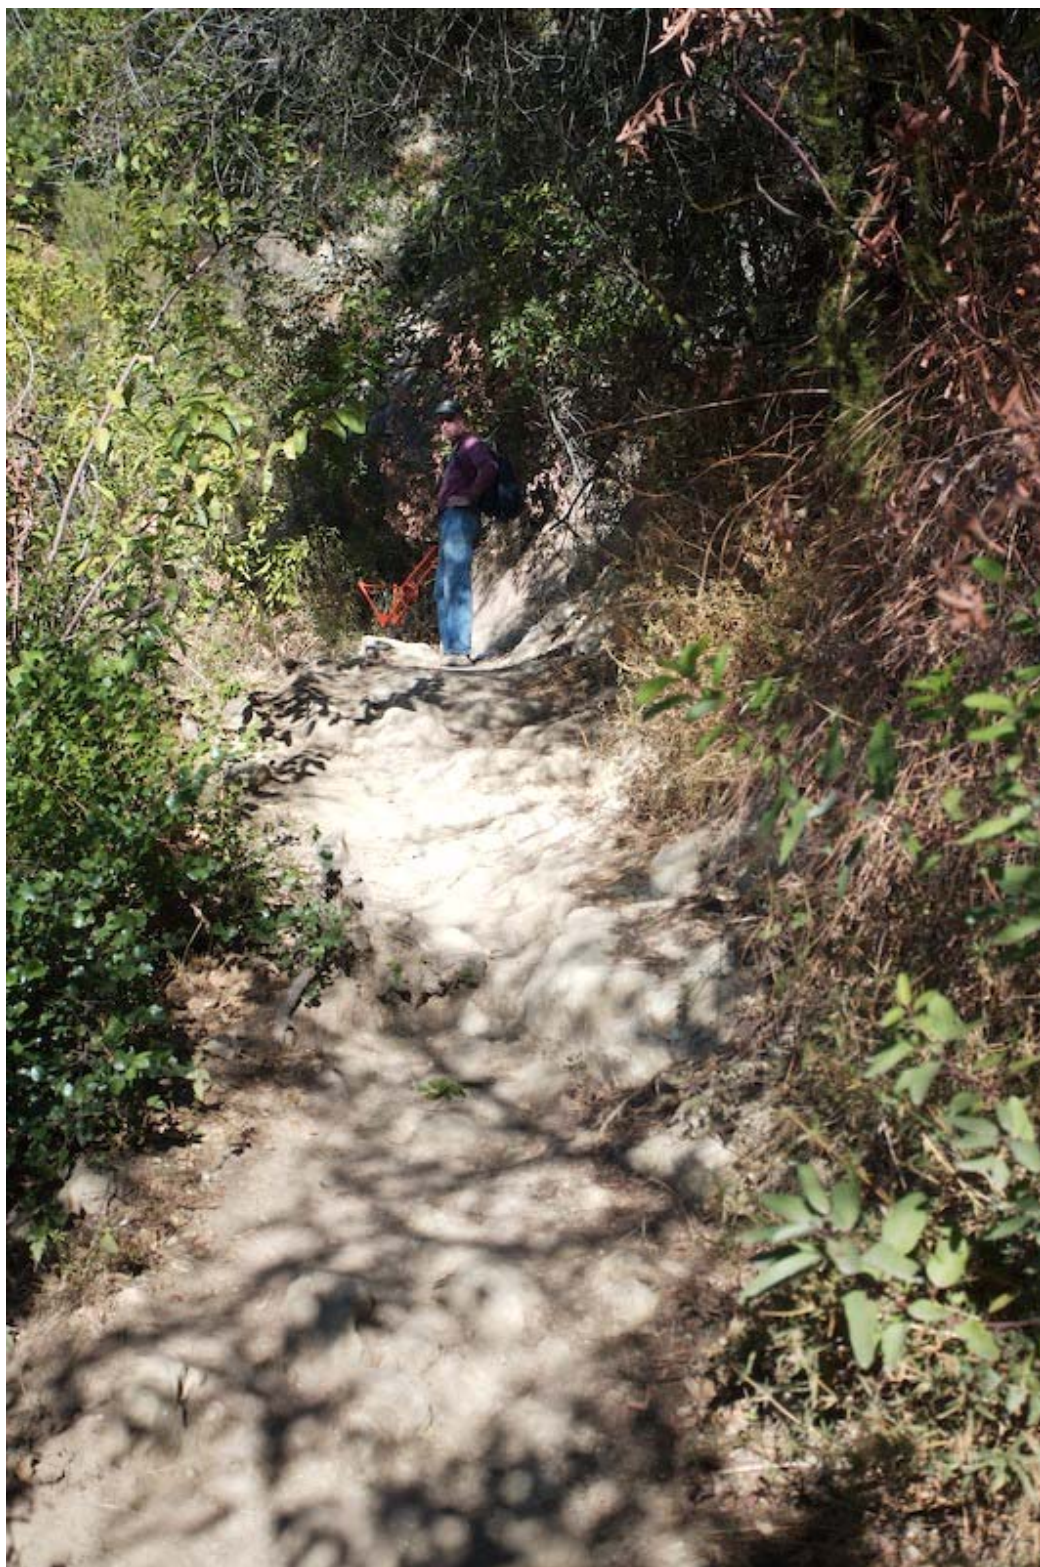
Numerous sections are similar to this: grade of more than 18%, off-sloping rock shelves, overhead brush that restrict sight lines.

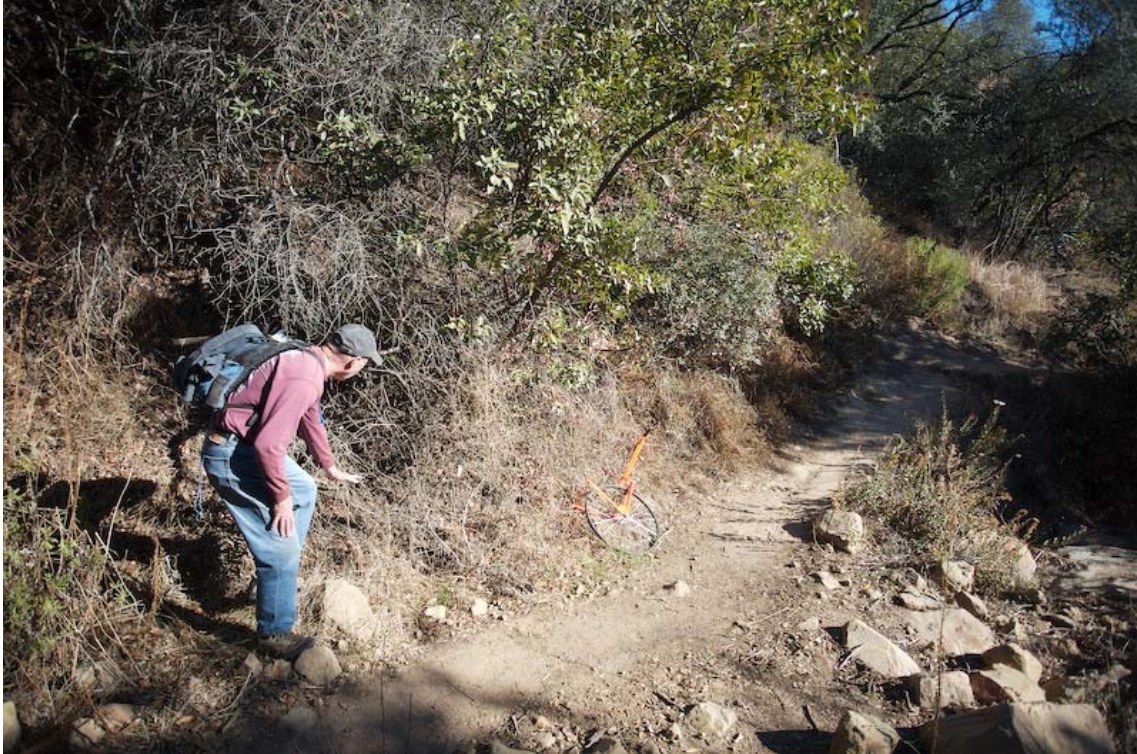
Paul is indicating how we might cut the trail up slightly into the hillside to create a “grade reversal”—a section where the trail shifts from a downhill to uphill grade. Here the side creek has been washing out the trail and eventually will eliminate it.

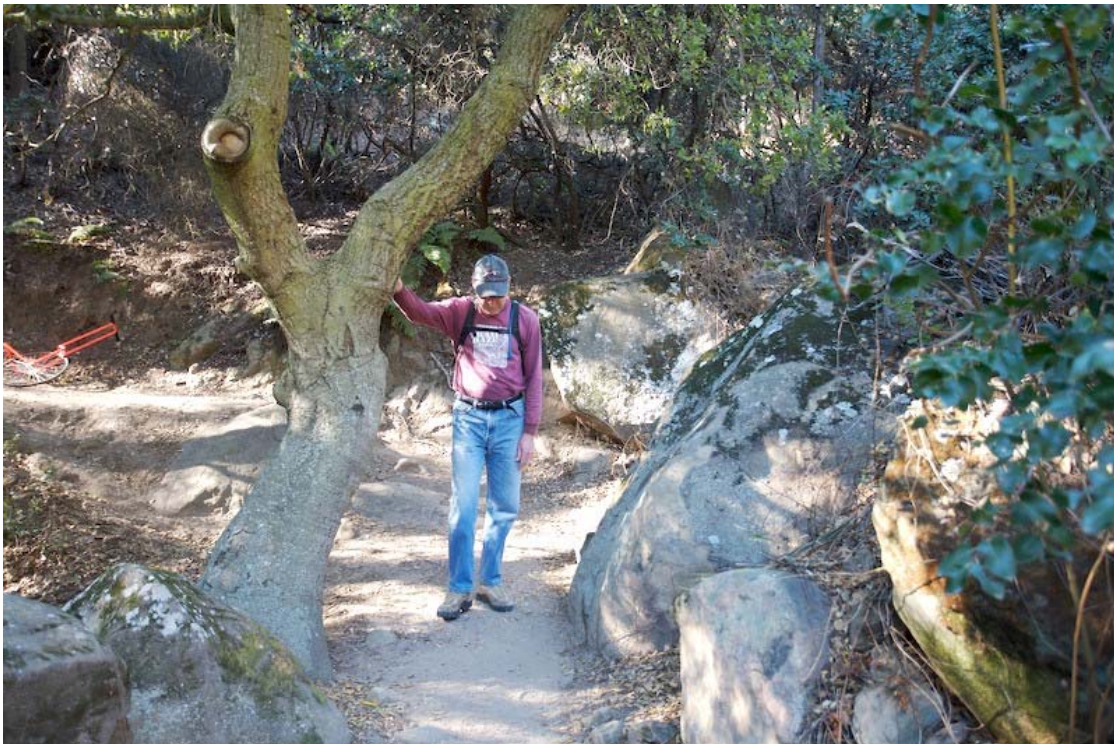
Overhanging limb makes passage by equestrians almost impossible. Note how large boulder forces users off the trail on the right.

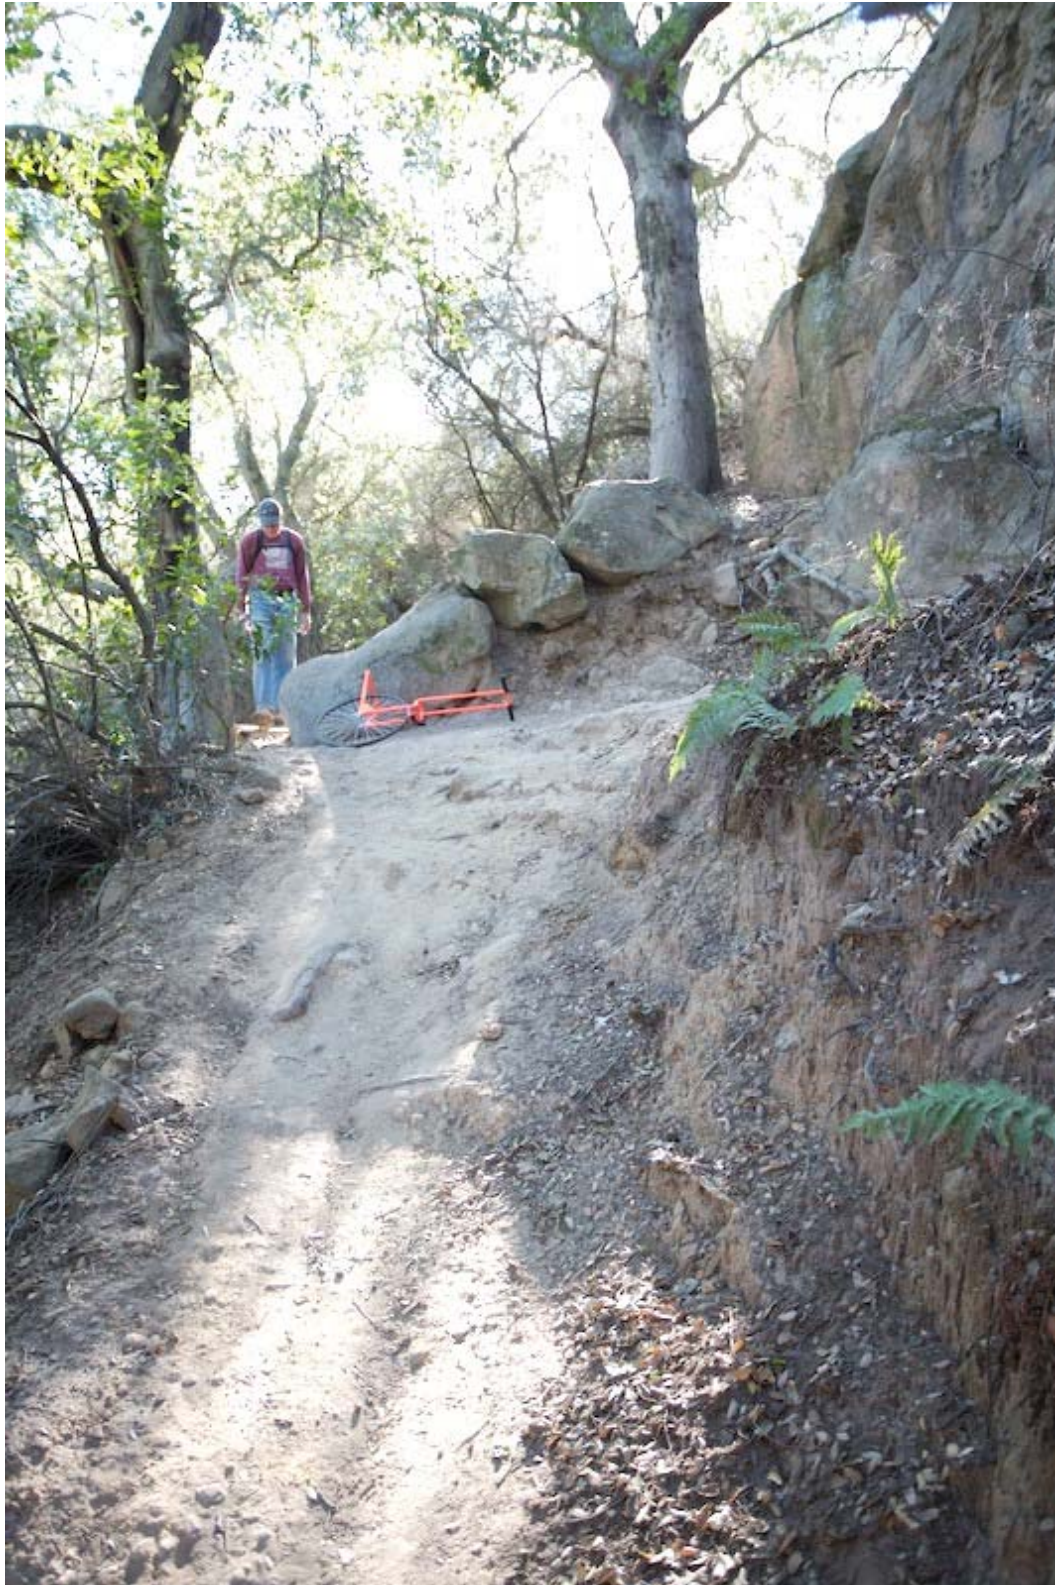
Typical of switchbacks on the way up to Inspiration Point. Rocks above make it difficult to widen the switchback at the top and steep slope on left makes it difficult on the down side leg (25% grade).

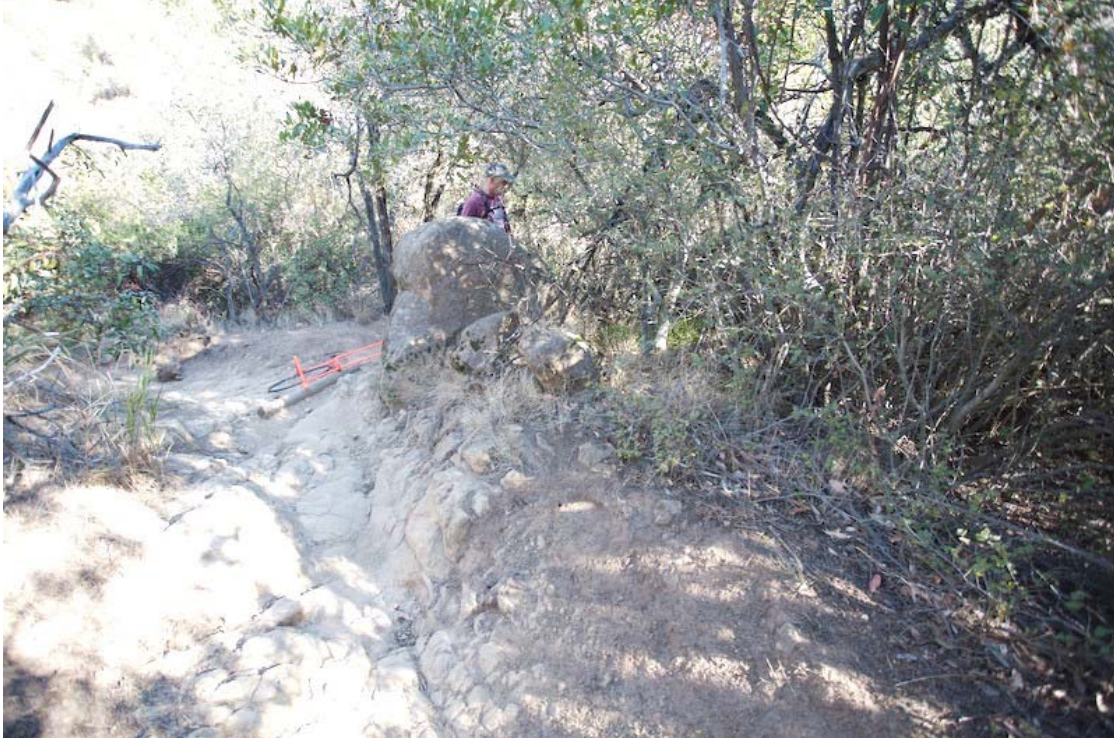
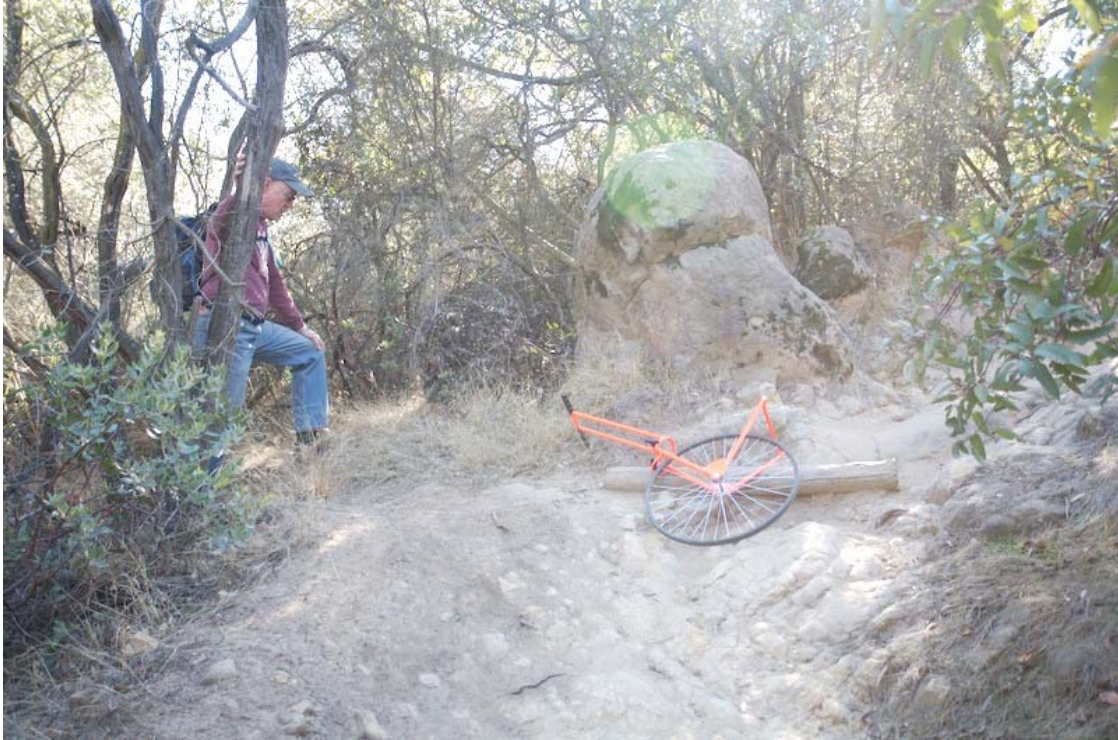
Note deep gullied section of trail in these tow views. This is recommended for a small re-route to take the trail around the large boulder. By circling to the right (above) into where the brush is, the grade will be lessened and we can add a dip that will take the water off the trail for good.

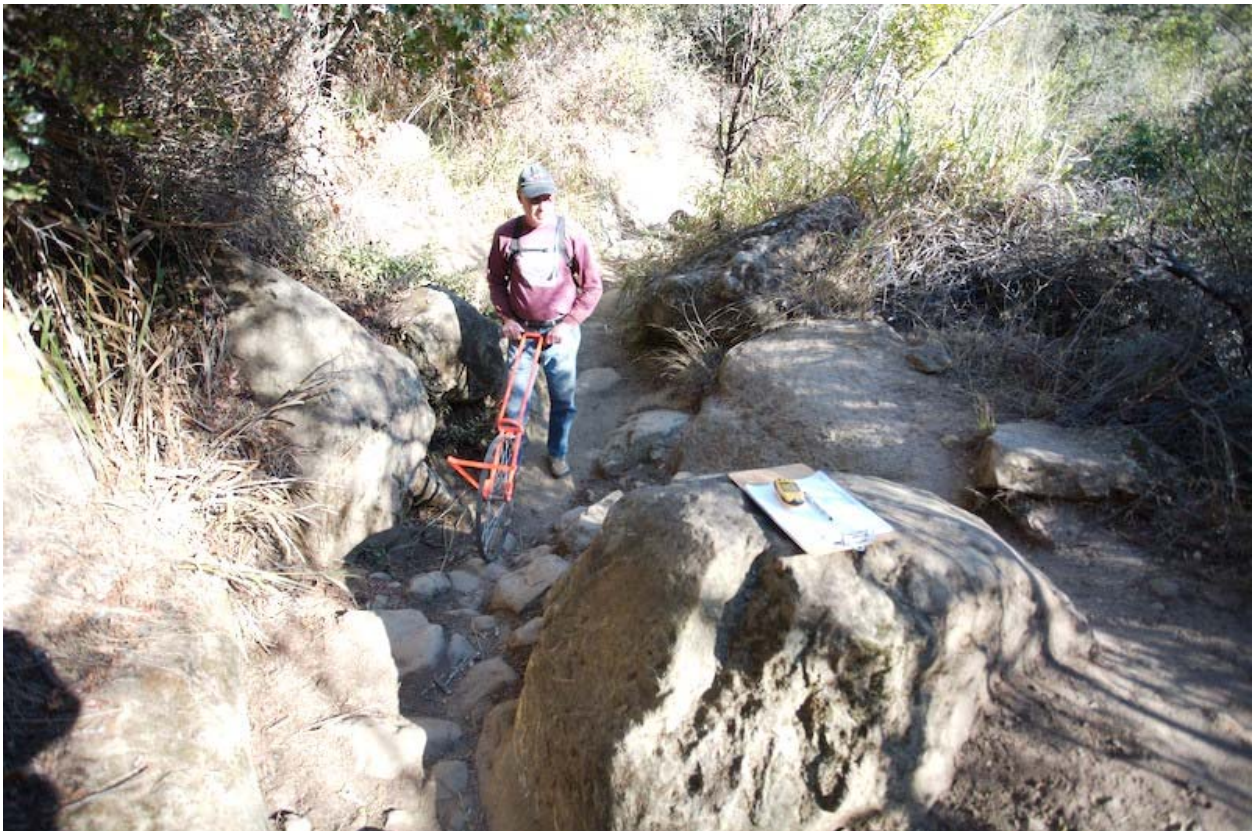
This pictures shows one of a number of sections that pass through slice material that has come off the hillsides—in this case very large boulders. Passage is not only difficult but note how mountain bikers are creating alternate trail on the right as they go up and over the rocks.

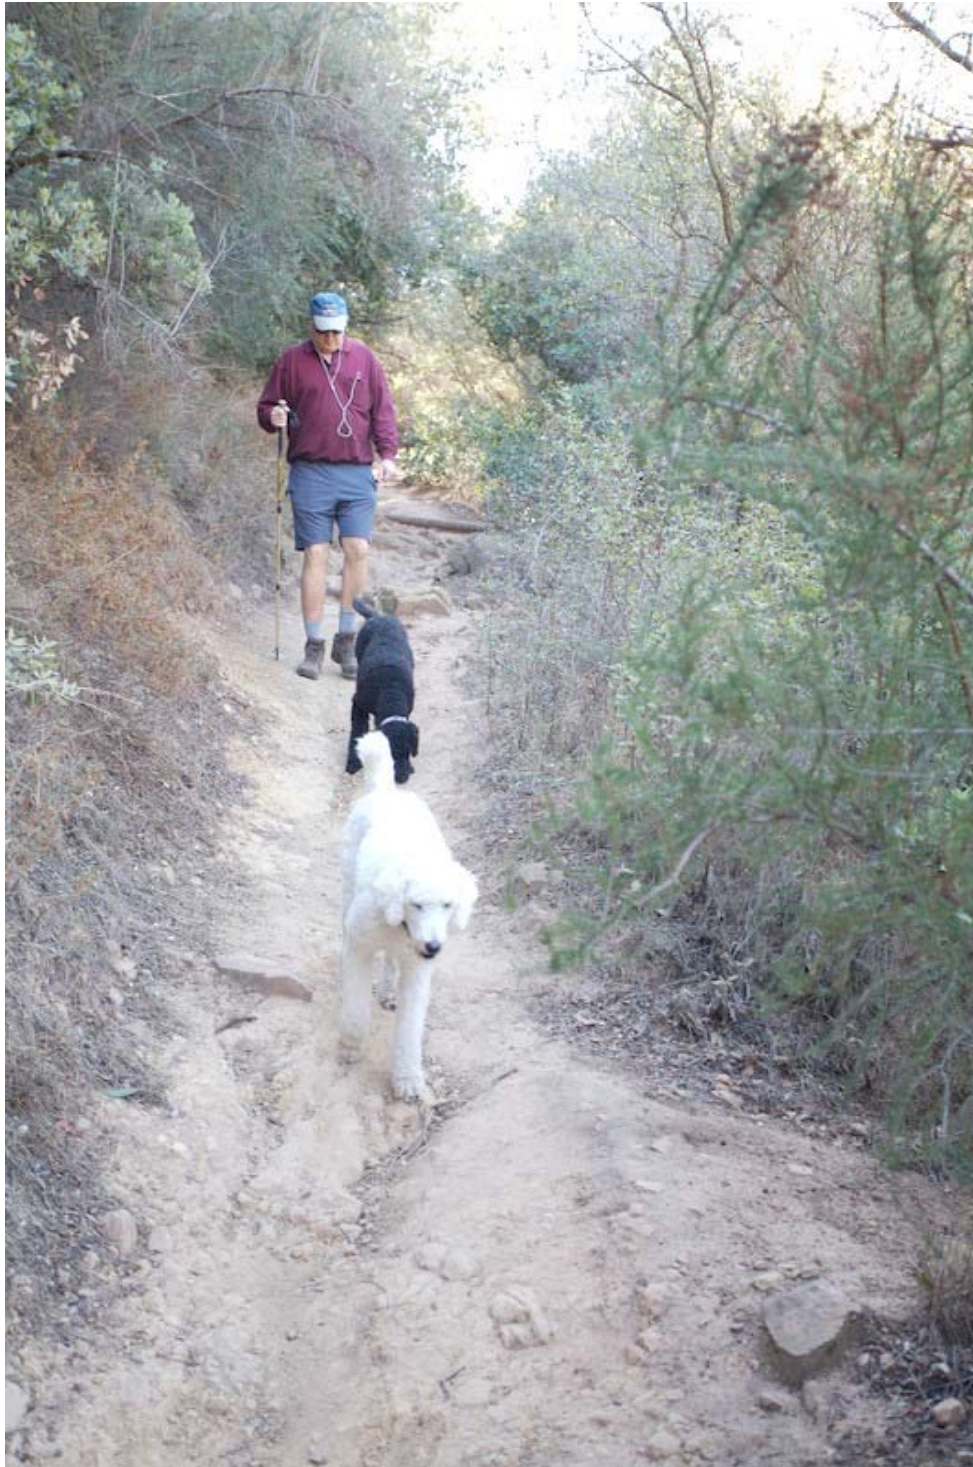
As you near Inspiration Point (last 200+ yards), the trail goes almost straight down the fall line. The trail is rutted and steep. Log retainers have been placed along the trail (see just to the right of

the hiker's waist) but no longer work. Small grade reversals and re-routes are recommended to fix the problem.

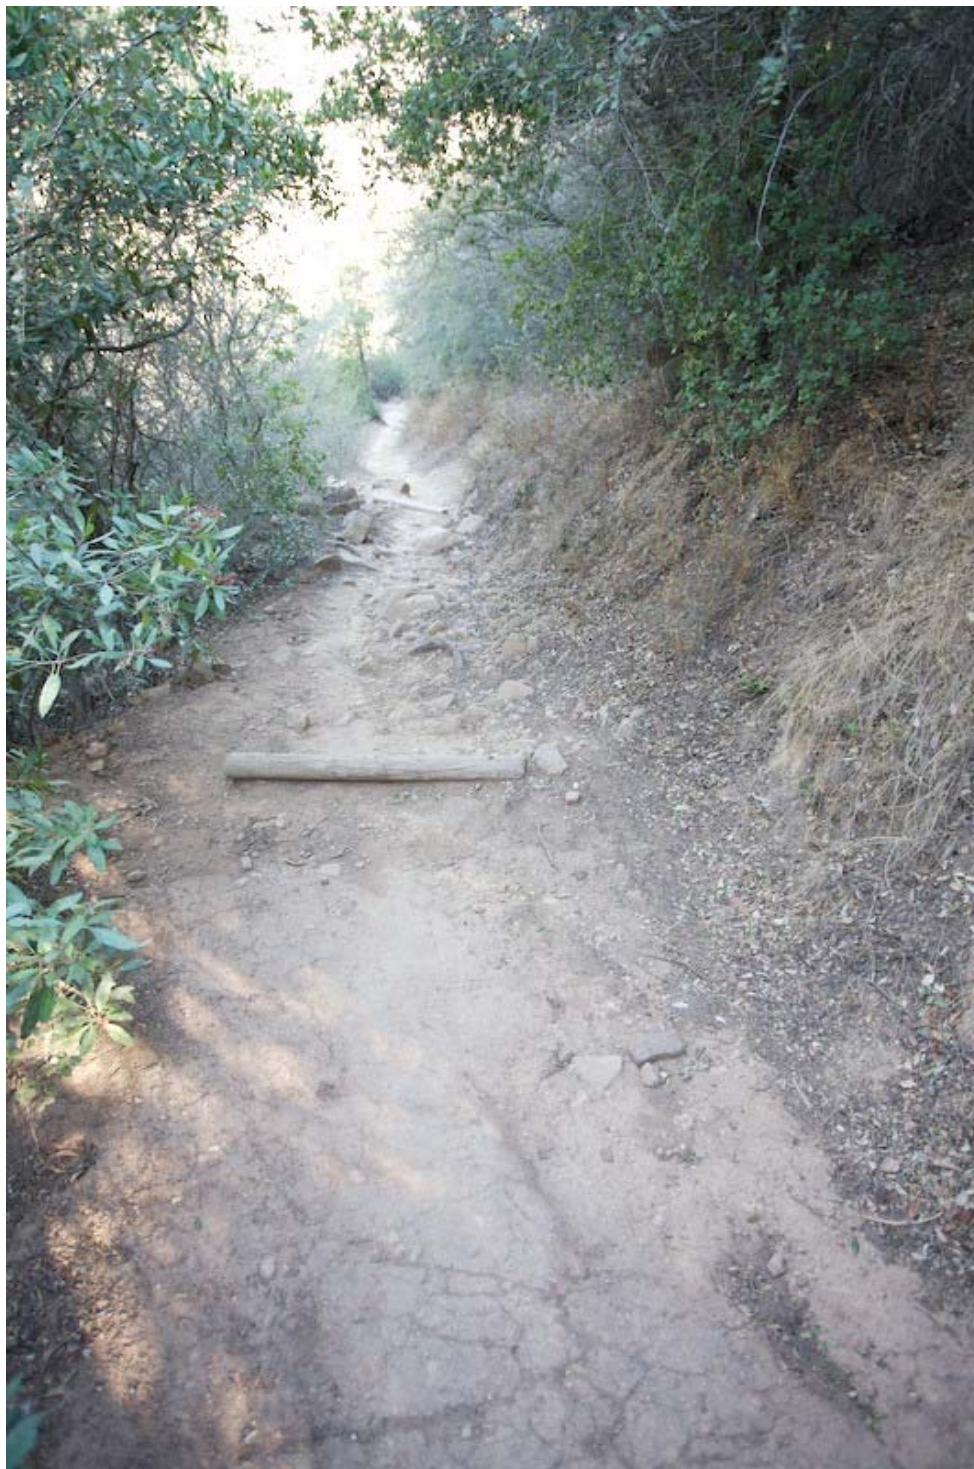
Same section seen from above. The grade is about 16%. It is slightly gullied at the upper part of the trail (lower part of the picture) but increases and continues around the corner for many more yards, getting deeper and deeper in the process.

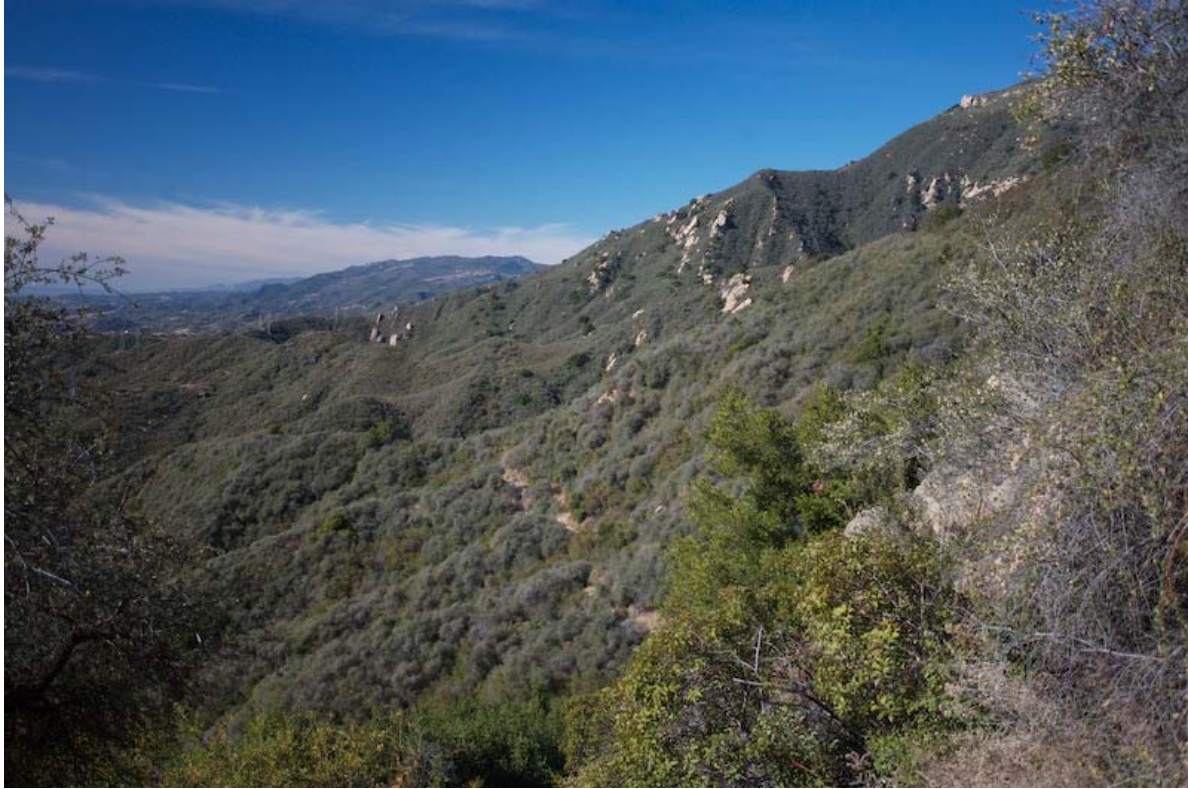
View west from the upper side of the San Roque section. The trail switches down to this level section then has another 14 switchbacks beyond that take you down into the canyon.

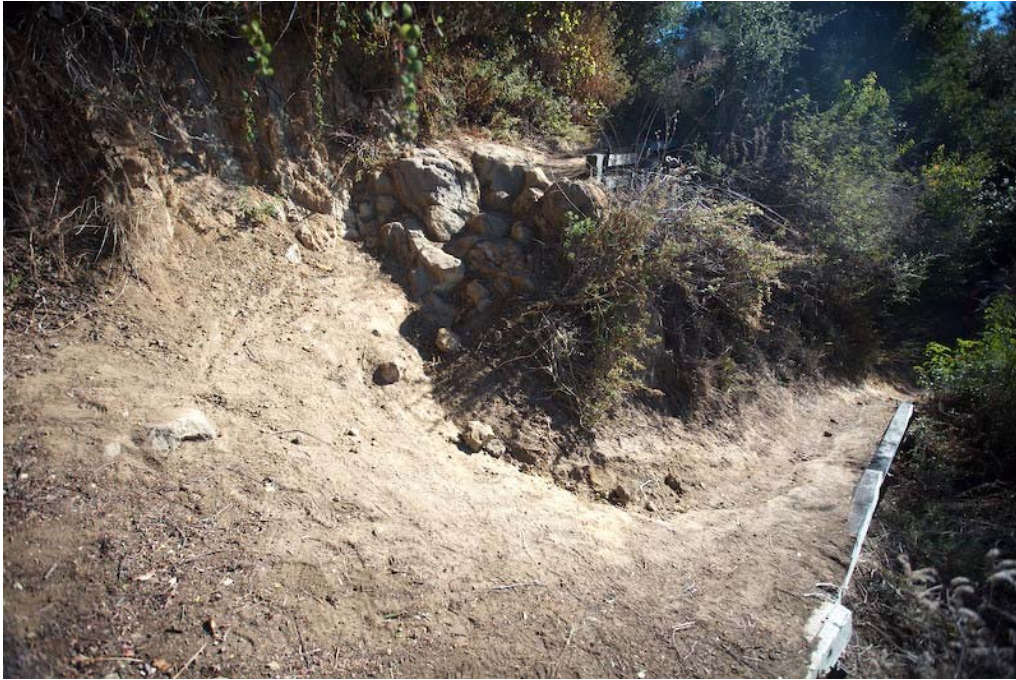
Shows one of those switchbacks with dropoff on the top leg and narrow tread on the lower leg. This is an example of a switchback that needs to be extended much further to the left, with the drop off eliminated and the retaining wall rebuilt so the tread is wider and safer. It is also an example of a section that is difficult to fix by hand and easy for the excavator.

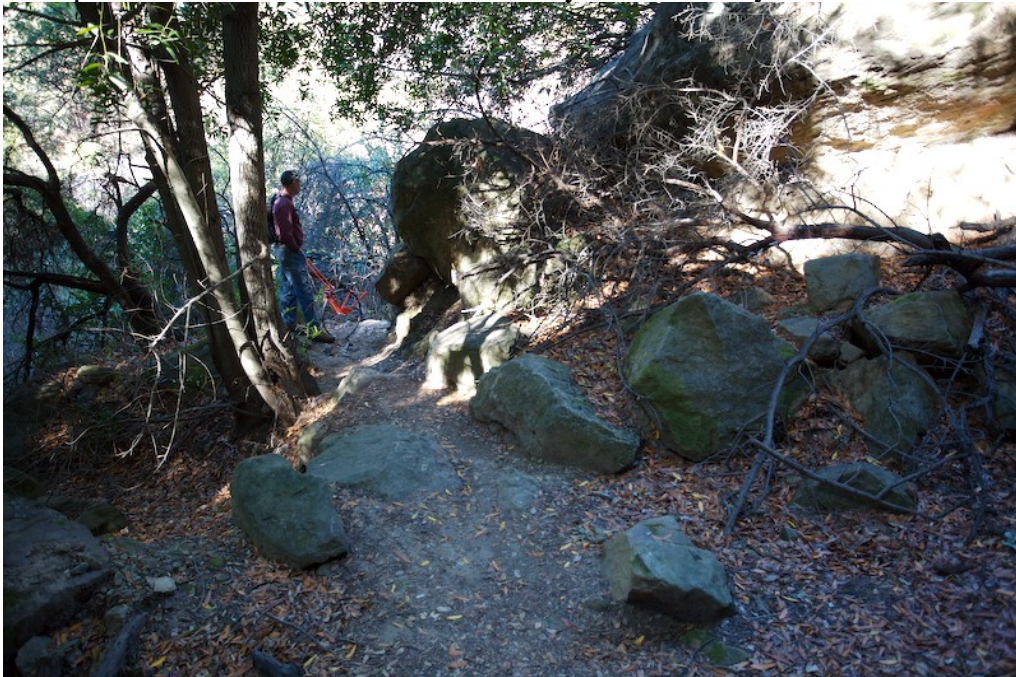
On the San Roque side there are numerous sections like this with tree and rock obstructions that create a narrow tread, poor sight lines and the potential for unsafe use. By moving rocks to slow bike traffic and widening the tread by adding retaining walls on the outside, safety can be improved.

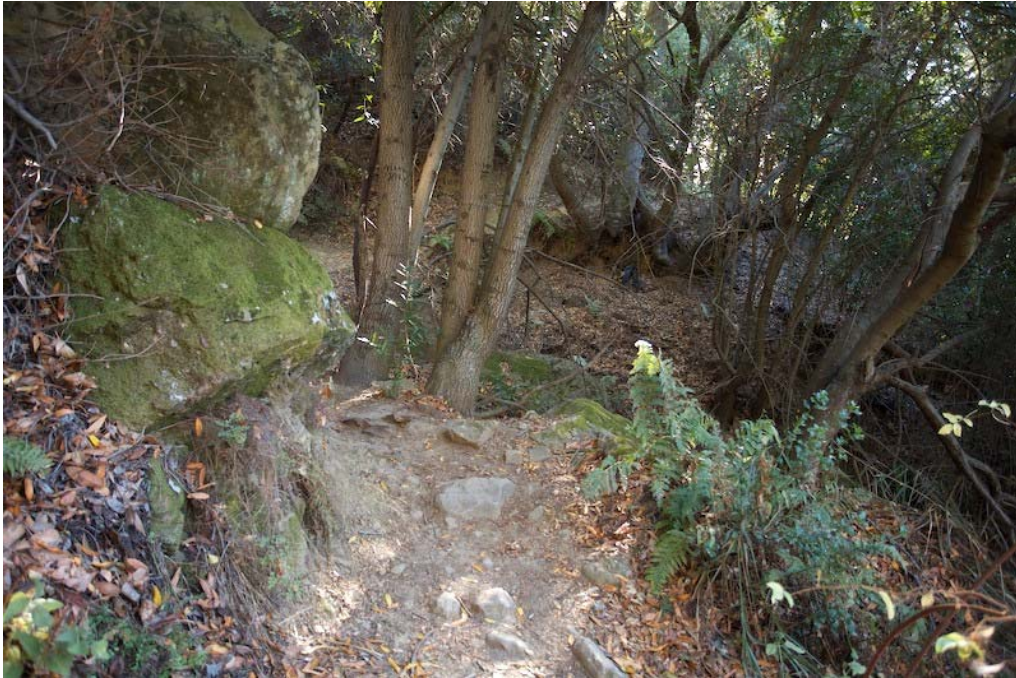
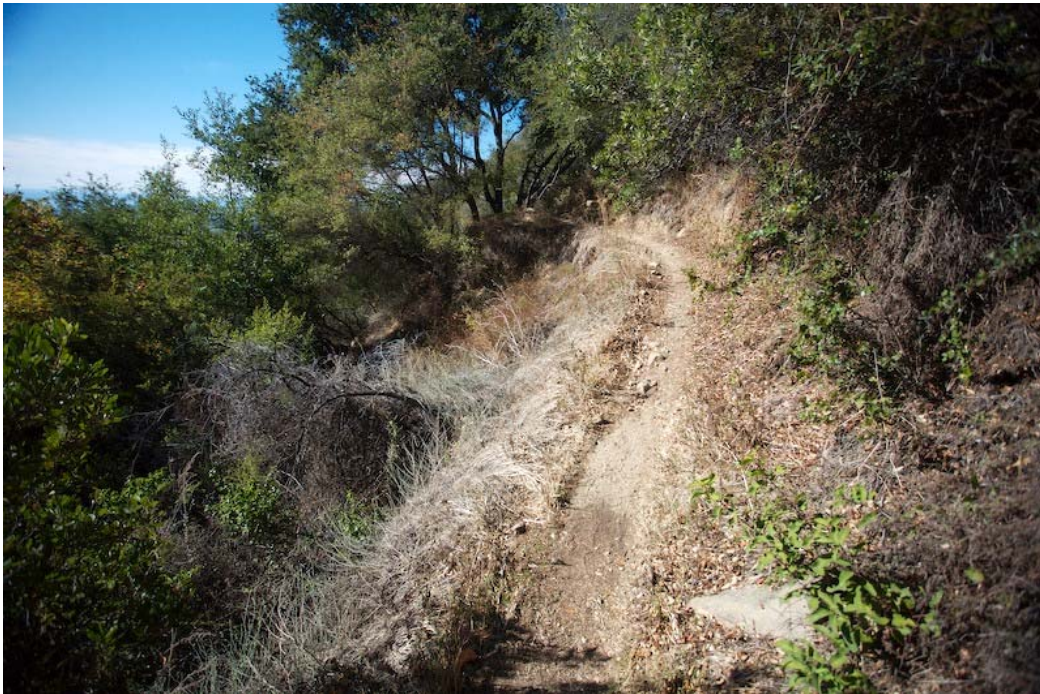
Even sections such as this can be deceiving. Overhanging brush forces users to the outside. Here the tread is almost on the outside edge. By removing the overhanging brush and using the excavator to cut into the back slope we can widen the tread and make use much safer.

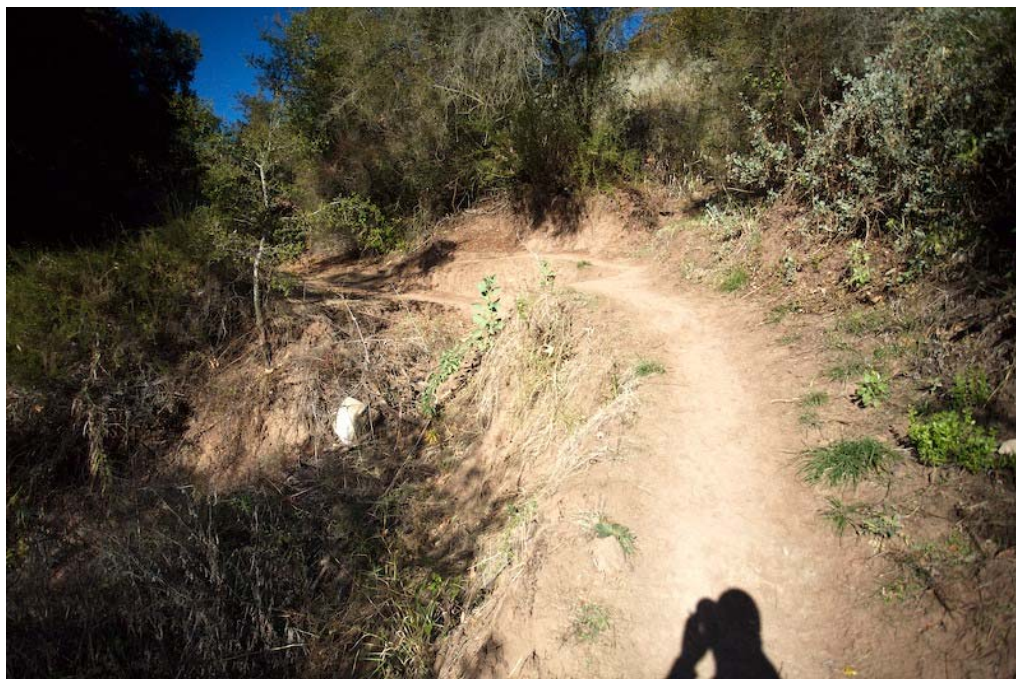
Note below how the down slope has slumped, creating an unstable trail bed. Cutting the tread further back towards the upslope can help eliminate safety issues.
